# Aircraft Carrier Flight and Hangar Deck Fire Protection: History and Current Status

**JANUARY 2005**

## **NAWCWD Technical Publication 8516**

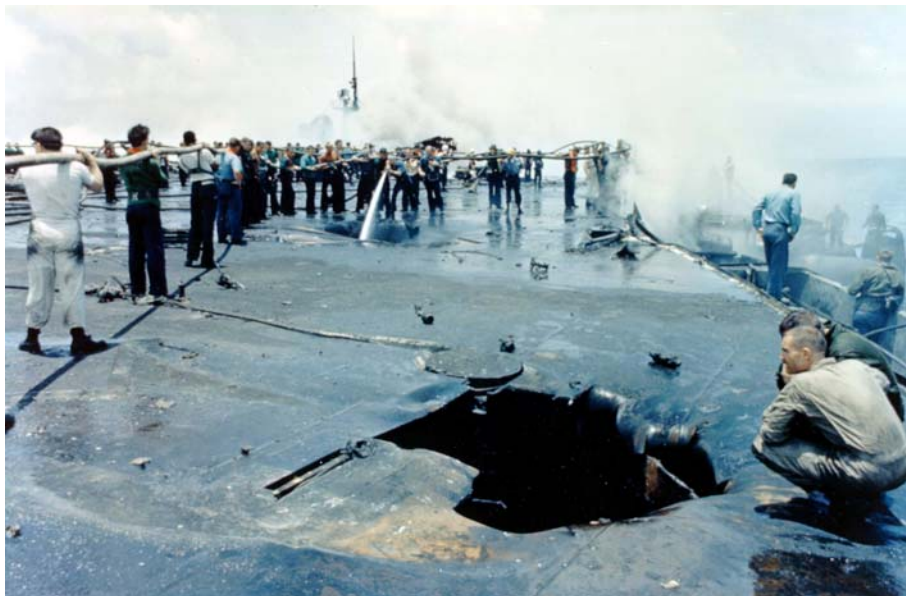
Altogether, 134 men were killed, 300 were injured, and 50 of those killed were in their bunks on the 03 level. During the incident 15 men were either blown, fell, or jumped overboard. The fire was initiated when a Zuni, for unknown reasons, shot across the deck from starboard to port, rupturing fuel tanks on an aircraft on the port side. The fuel instantly ignited, causing adjacent fuel tanks and ordnance to rupture. From there it escalated as more fuel tanks ruptured, more fuel was dumped on the deck, and more ordnance cooked off. The *Forrestal* is also famous for another reason: the pilot of the aircraft that was struck by the first firing of the Zuni was Senator John McCain. His book he gives an account of that incident.

FIGURE 83. Bomb Hole on *Forrestal*.

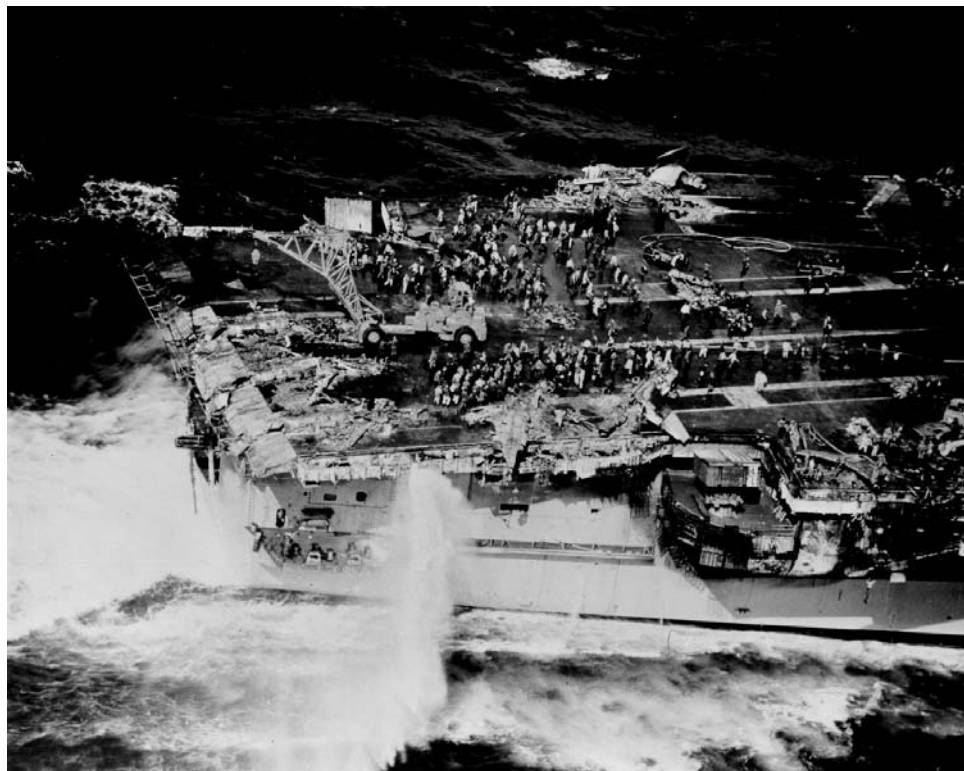
FIGURE 85. Destroyed Aircraft on the *Forrestal*.

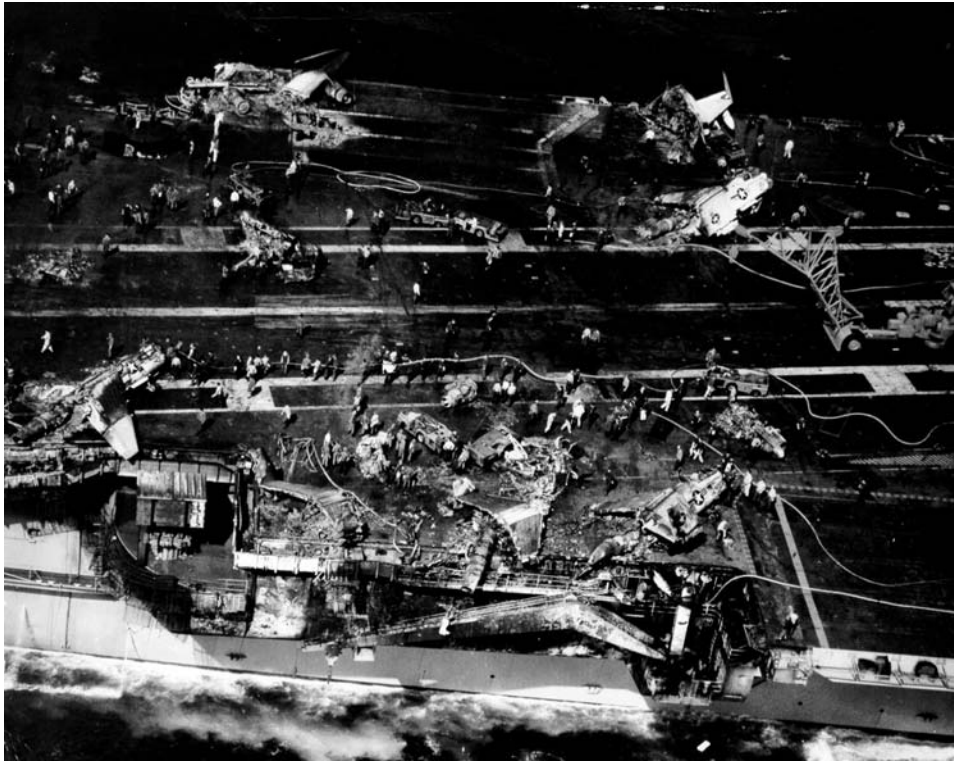
FIGURE 86. Close-Up *Forrestal* Damage.

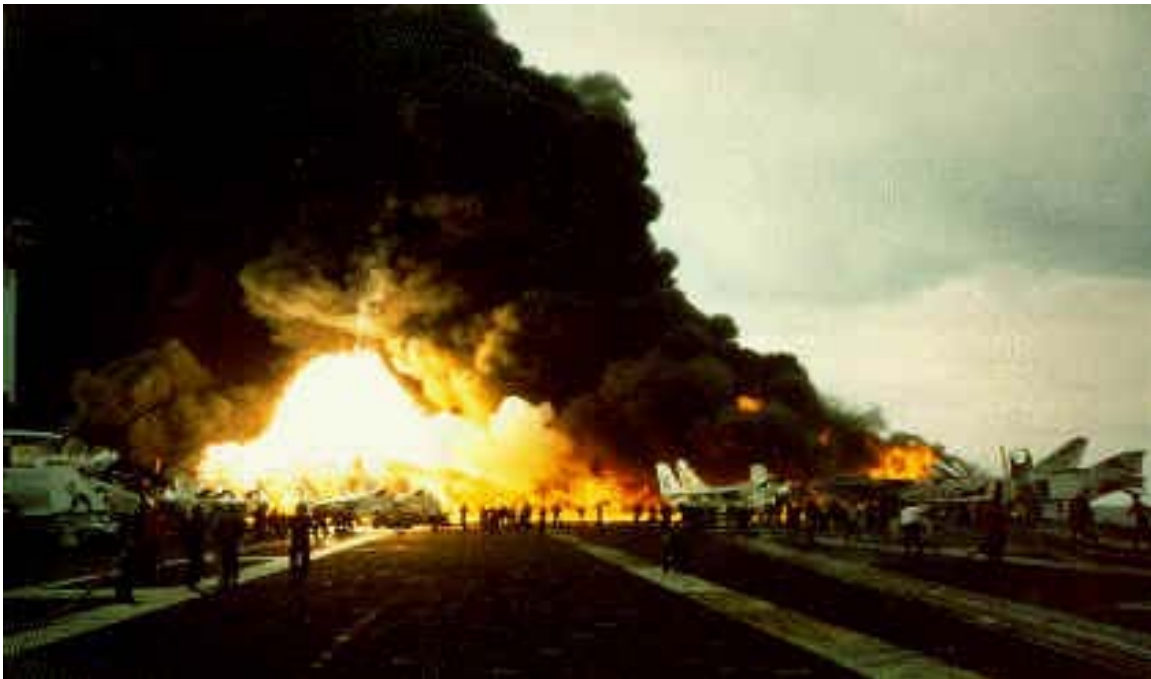
Figures 87 through 89 are from the fire 18 months later on the *Enterprise*. This fire occurred when a Zuni rocket pod was cooked off accidentally by the hot exhaust from a jet engine starting unit. The jet engine starting unit was parked so the exhaust impinged directly on a Zuni pod. They had shortened the starting hose; as the hose became frayed they cut off the worn ends and recoupled it. They reduced the length of the starting hose, which caused the starting cart to have to be moved closer to the aircraft. In this incident, it was actually so close that the hot exhaust cooked off the Zuni rockets. A total of 40,000 gallons of jet fuel were consumed. Figures 87 and 88 show the fire as it was covering the entire aft end of the flight deck. A total of 28 people were killed on the *Enterprise*, 343 injuries occurred, and eight holes were created in the flight deck as a result of the cookoff of bombs.

FIGURE 87. *Enterprise* Fire.

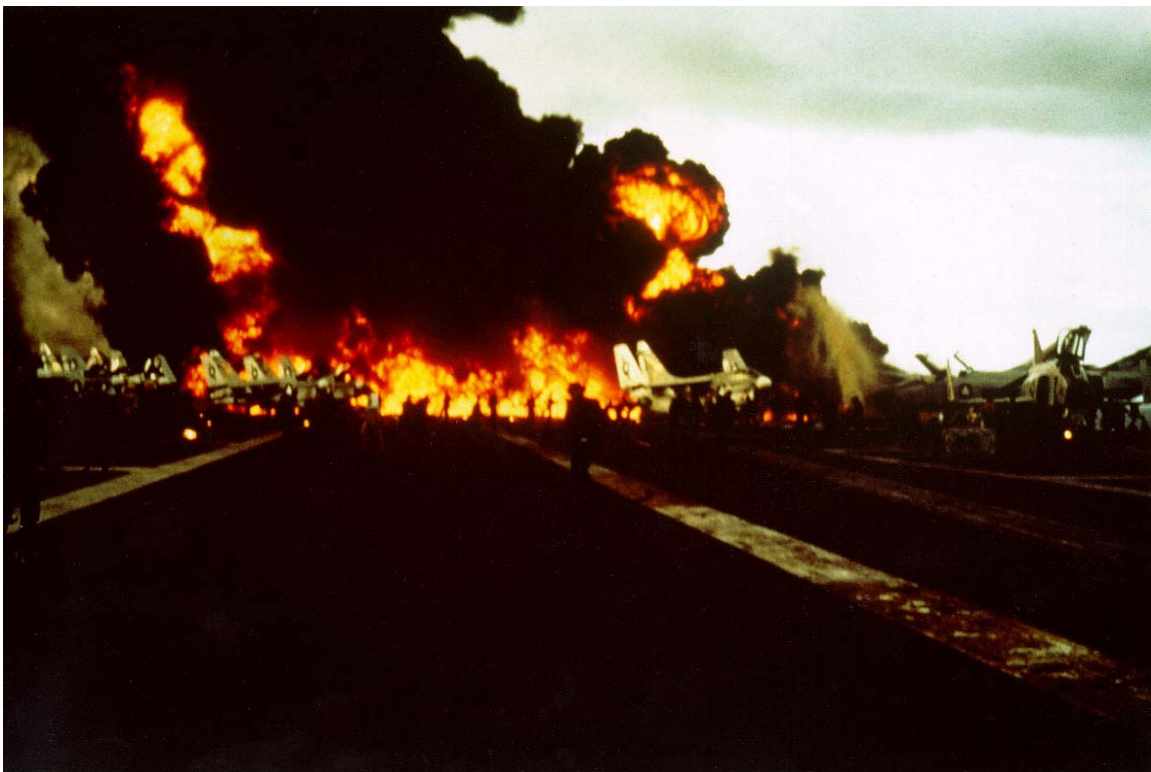
FIGURE 88. Fire Covers Aft End.

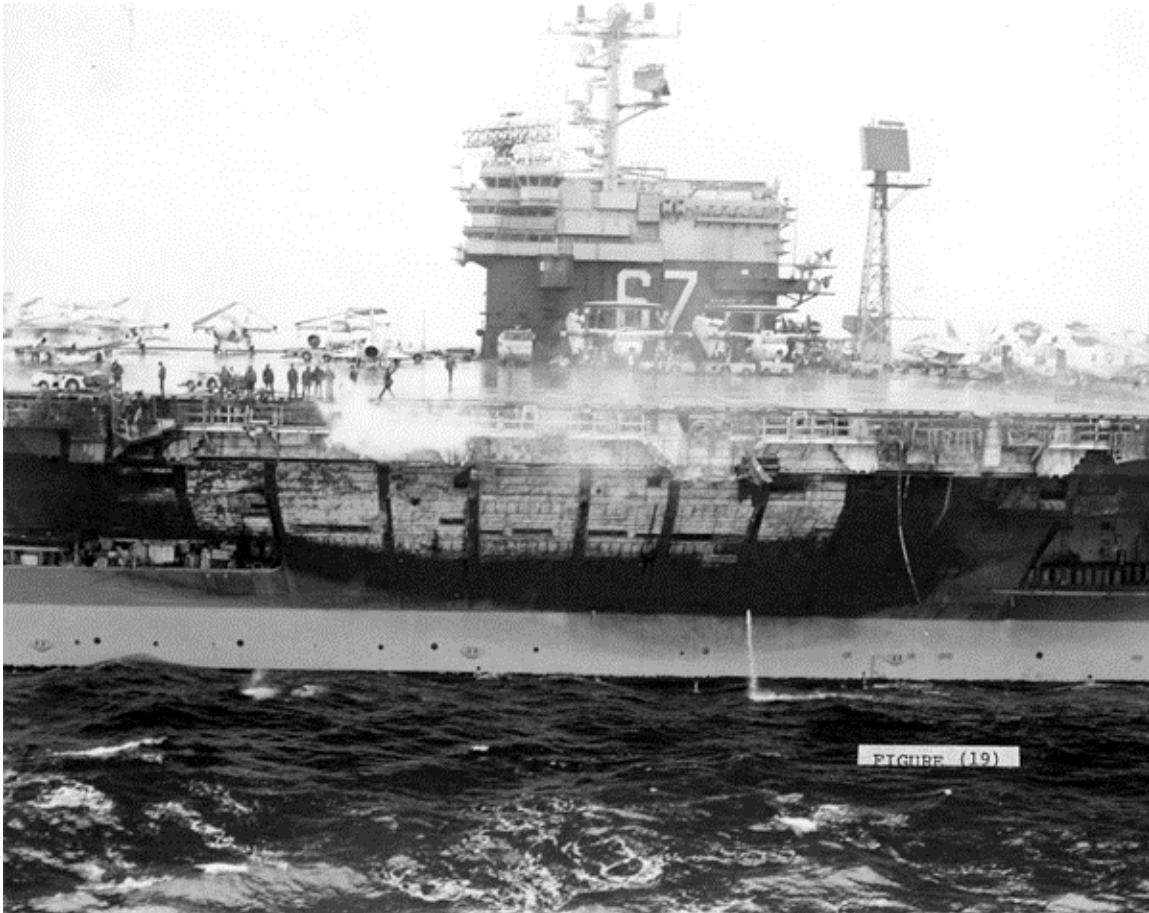
Figures 90 and 91 are photographs of the flight deck and the hangar deck of the *Kennedy*. Scorch marks on the side of the *Kennedy* are evident in Figure 91. When the *Belknap* hit the *Kennedy*, the *Kennedy* was in the process of fueling aircraft, so all of the JP-5 fueling risers were pressurized. The fuel risers were ruptured by the *Belknap* and about 2,000 gallons of flaming jet fuel spewed down on top of the cruiser. While the *Belknap* was hung up underneath the angle deck, and until they were able to back off, the flames impinging on the side of the hull caused fires internal to the *Kennedy*.

FIGURE 91. Scorch Marks on the *Kennedy*.

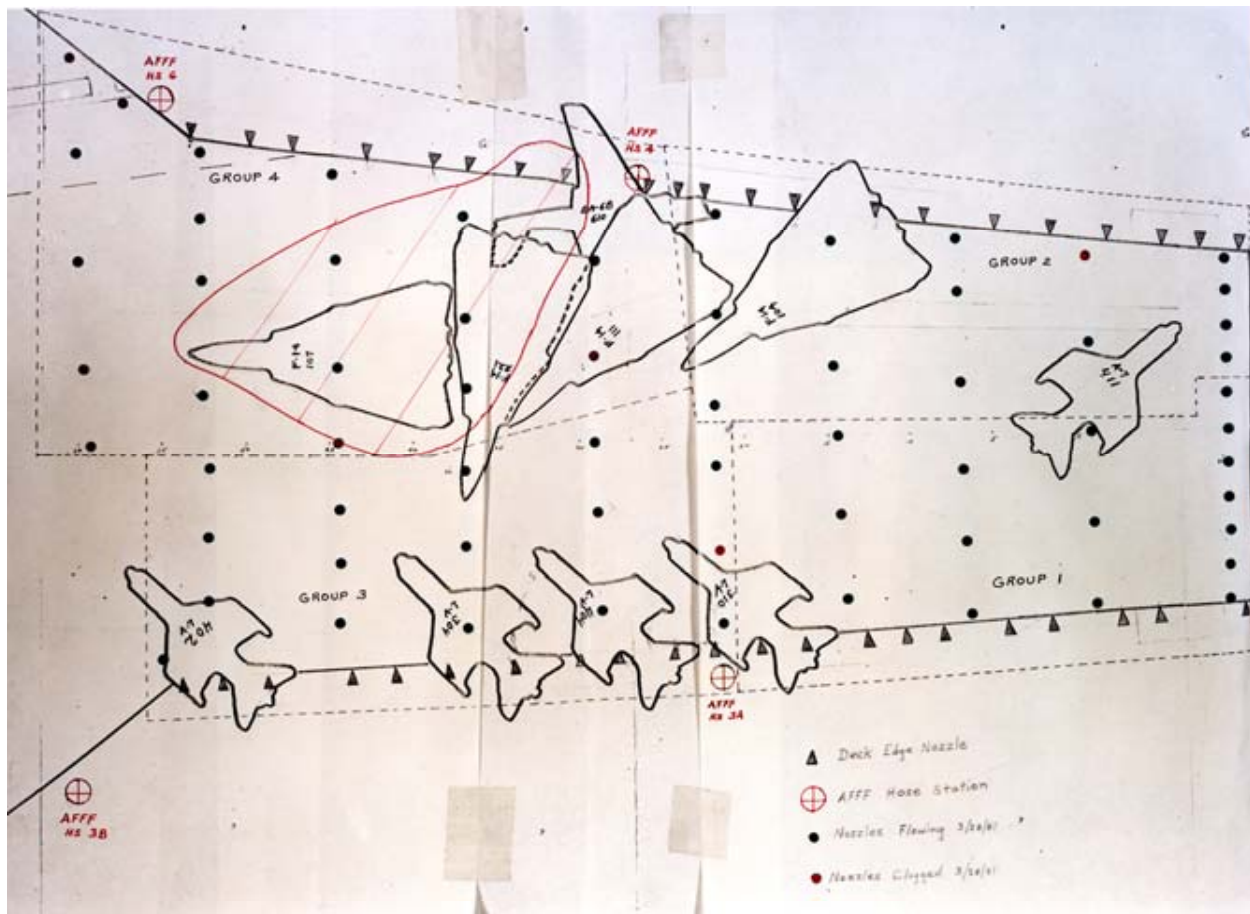
Figure 92 shows the fire area on the *Nimitz*. The crash, and resulting fire, occurred after an incoming EA-6B aircraft inadvertently lined up on the foul line rather than the centerline of the angle deck in night landing. The centerline strobe lights were out. The aircraft plowed into a pack of F-14s on the bow. Figures 93 through 95 show the fire on the bow. Initially the fire party had difficulties fighting this fire because they had to approach into the wind. No hose stations were all the way forward on the bow of the *Nimitz*, so they could not deploy hose lines forward of the incident. Because of this, all *Nimitz*-class carriers now have hose stations all the way forward, to allow better hose coverage for this sort of fire. Figures 96 through 98 were taken the day after and show the damage to some of the involved aircraft.

FIGURE 92. Fire Area on the *Nimitz*.

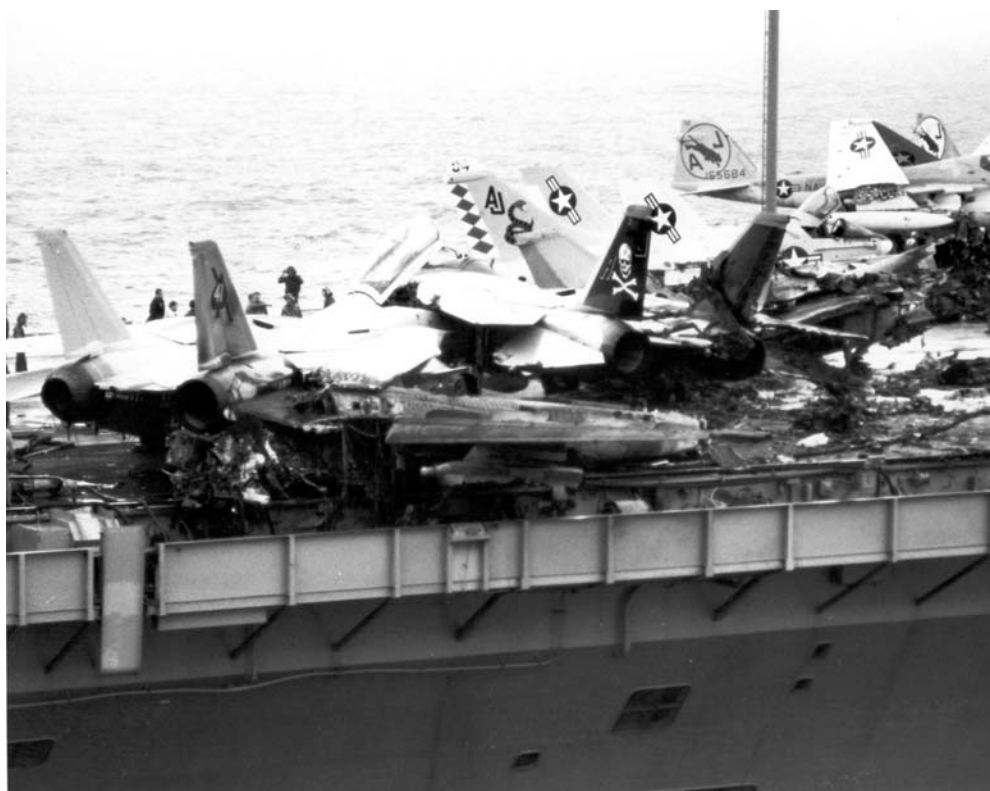
FIGURE 96. *Nimitz*—Post Fire Damage.

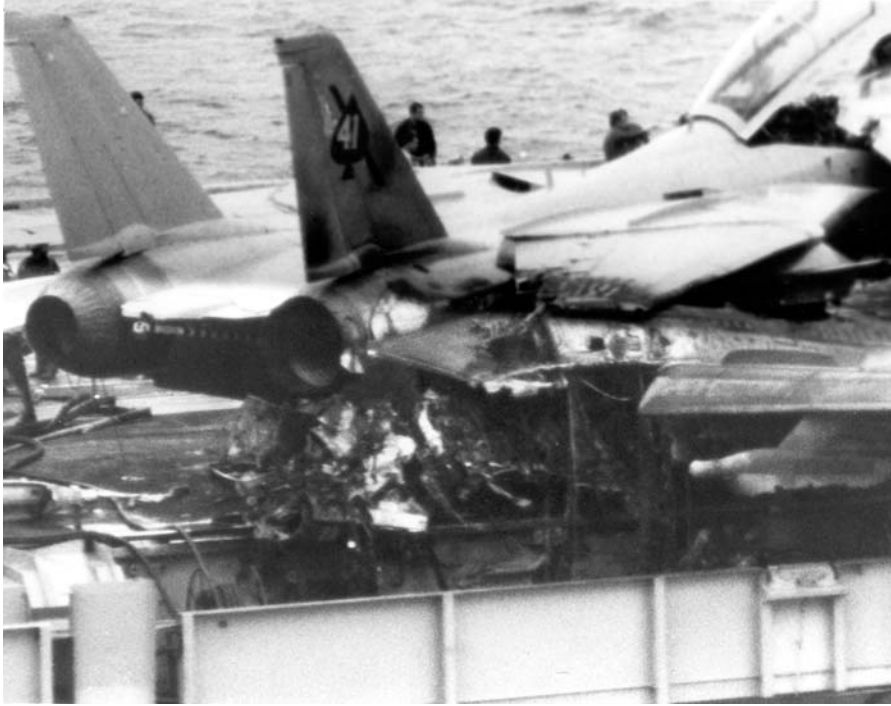
FIGURE 97. Close-Up of EA-6B Remains, F-14 in Background.

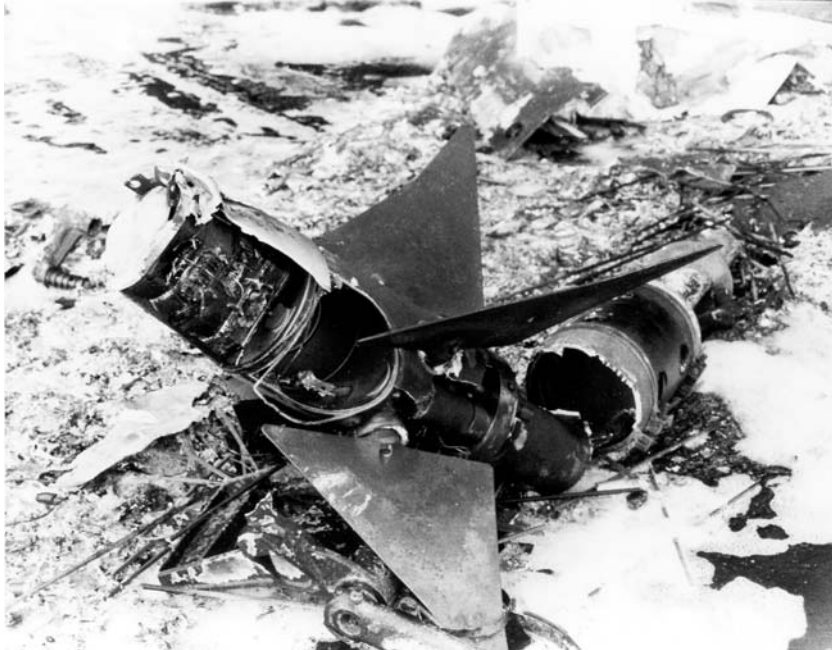
FIGURE 100. Remains of Missile Motor.

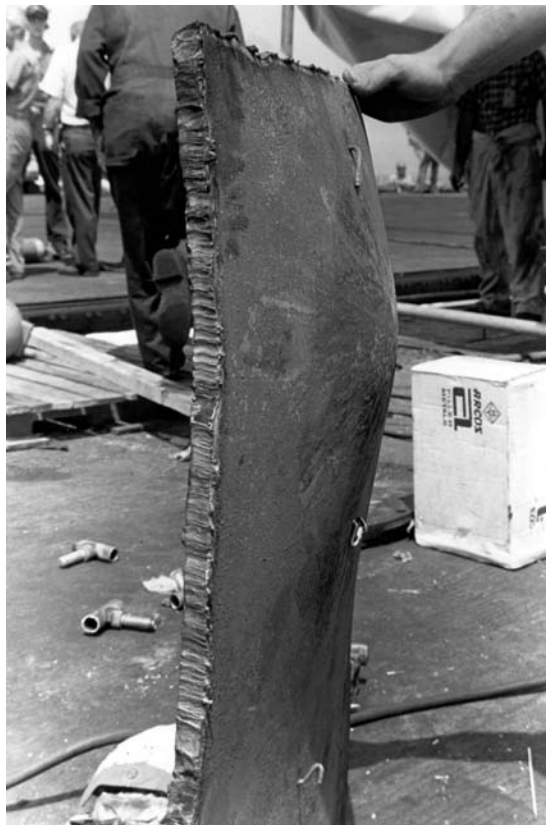
FIGURE 101. Dimple in *Nimitz* Flight Deck.

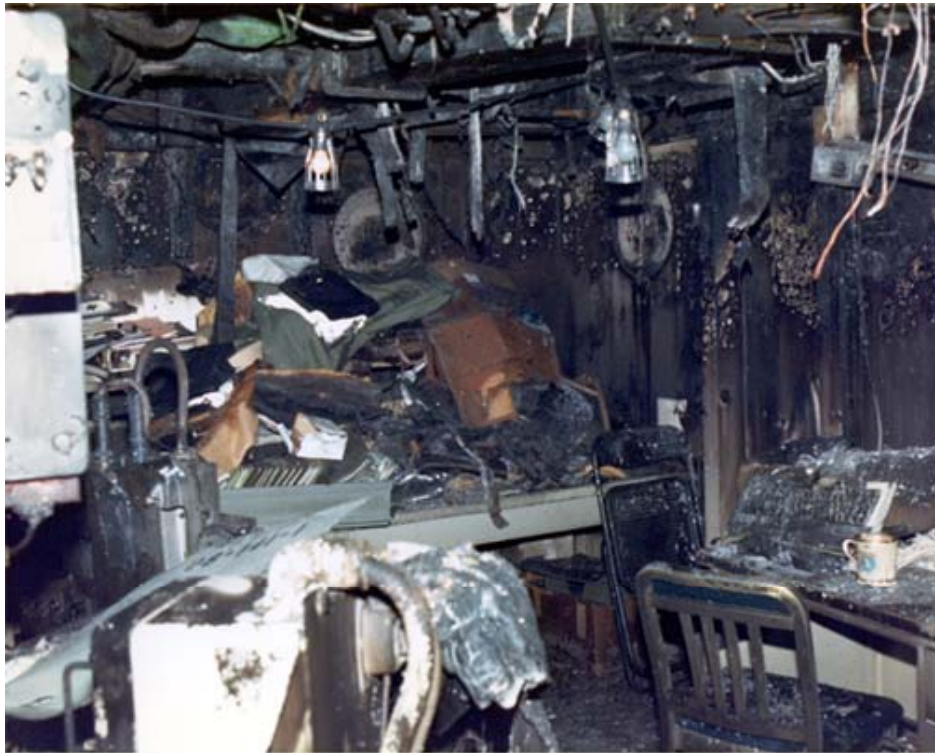
FIGURE 102. *America* Flag Plot Fire Damage.

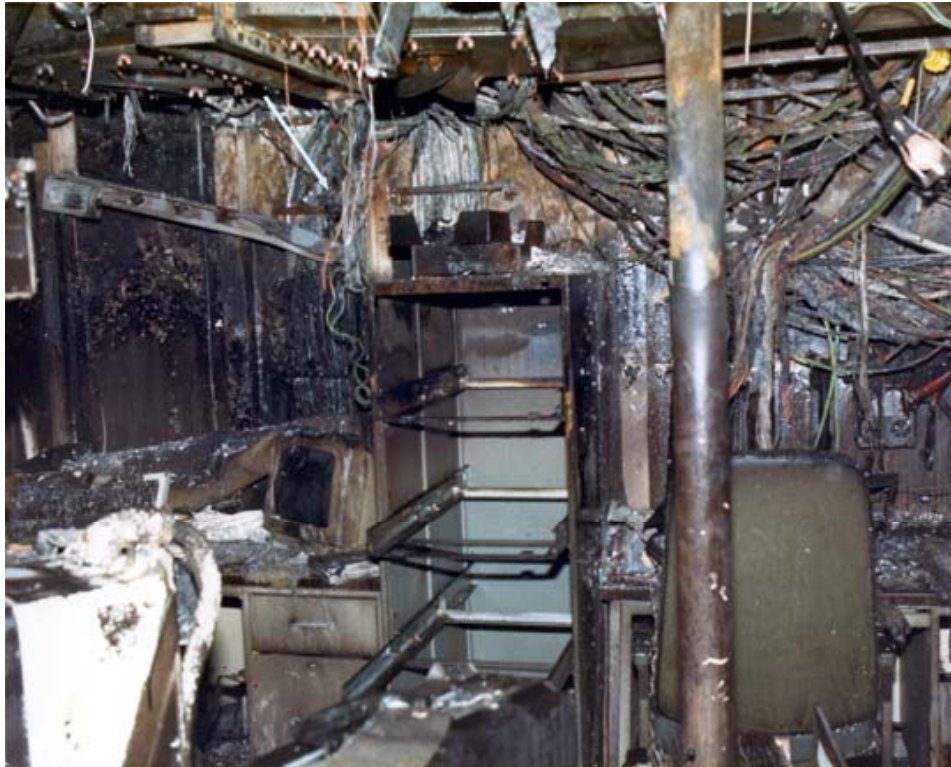
FIGURE 103. *America* Flag Plot Damage.

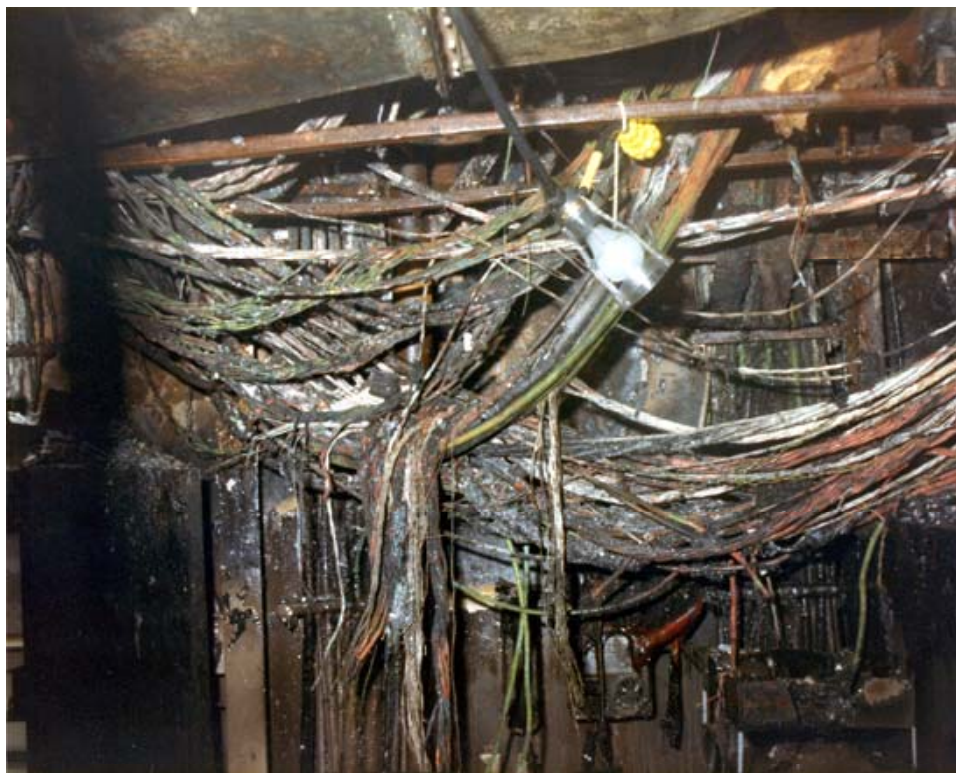
FIGURE 104. Extensive Burning of Cables.

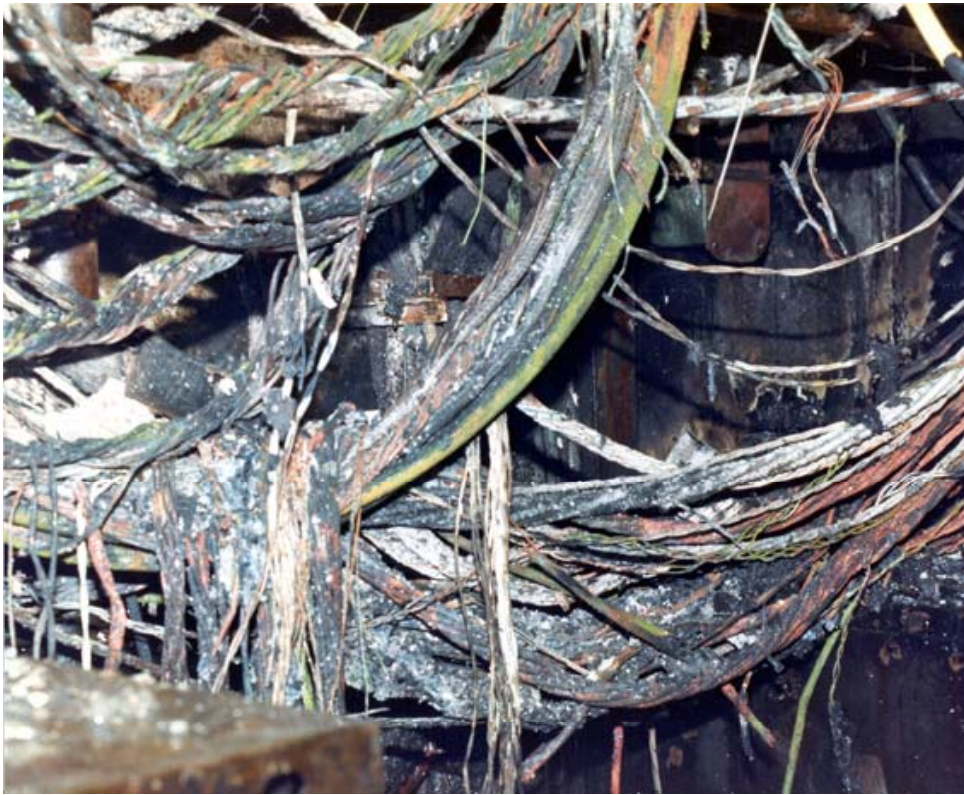
FIGURE 105. Close-Up of Cable Damage.
